ASSOCIATED UNDERWATER SERVICES, INC.

STARKIST SAMOA INC/ CHICKEN OF THE SEA

***Waste Water Outfall
Inspection & Repairs
January / February 2008***

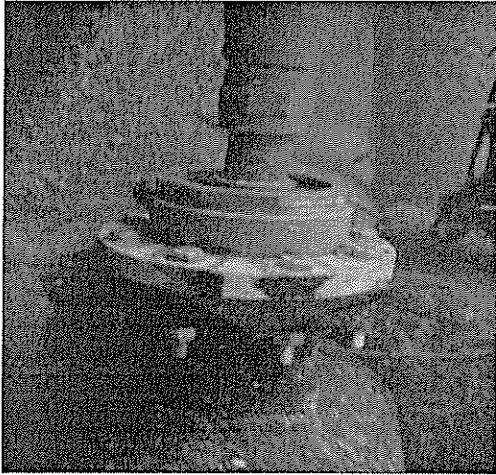
At approximately 2/3 distance from the west end of the dock we observed a 30" stainless steel pipe clamp on the outfall. While the clamp was in good condition we did observe a small leak at the bottom (6 o'clock position) of the clamp. Six feet offshore of this clamp we observed a six inch diameter tie in connection flange that had been blanked off. A large leak was observed coming from blind flange gasket. It appeared that the blind flange bolts had corroded and loosed the blind flange.

Photo 1: 6" tie-in connection with new gasket and bolts

The Leak at 6" tie -in with blind flange: We removed this piece, installed new gasket and stainless steel bolts and re-install. Leak was stopped. See Photo 1.

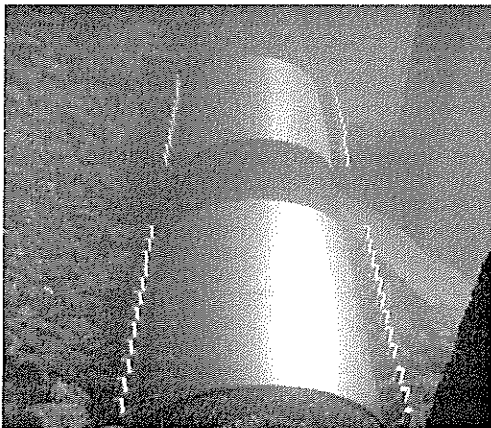
Photo 2: New 60" spool piece with (2) new stainless 30" long pipe clamps 2/3 from west end of CCS dock

Saturday 2/2/08: Cut out existing 30" long stainless steel clamp at 2/3 point location on dock. We installed new 60" piece of HDPE pipe. Installed two 30" long stainless steel clamps
